PHASE 3 SUSTAINABILITY PRACTICES + ST. MARY'S RD PHASE CONTINUITY

DECK PLAZA MATERIALS + PERSPECTIVE VIEWS

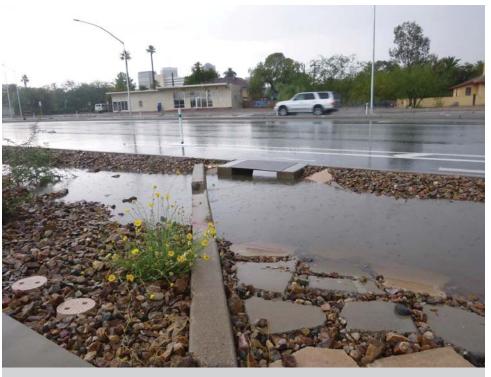
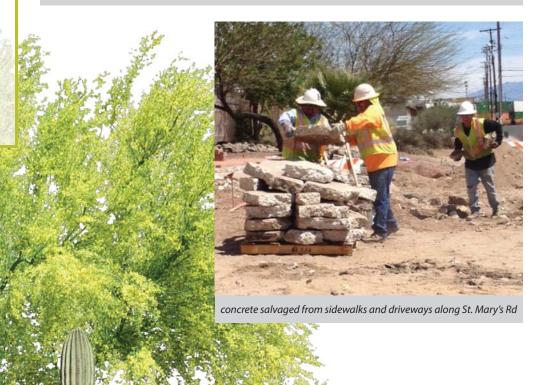
on-site stormwater management along St. Mary's Rd [scupper, recessed planting, check dam]

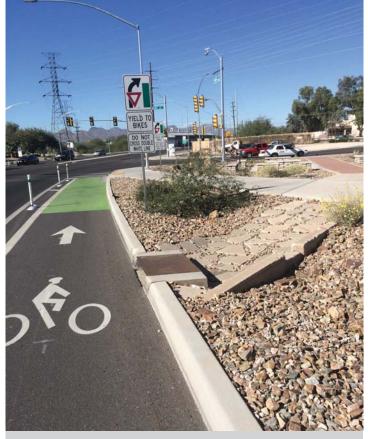
scuppers divert water from St. Mary's Rd into planting areas

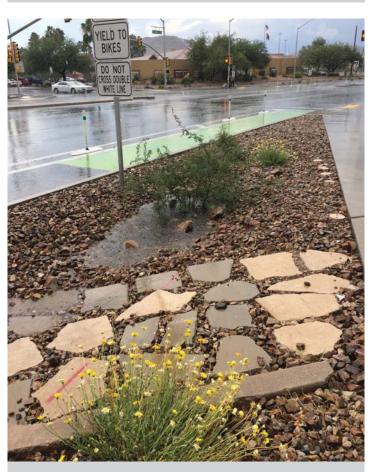
recycled concrete scupper armor along St. Mary's Rd

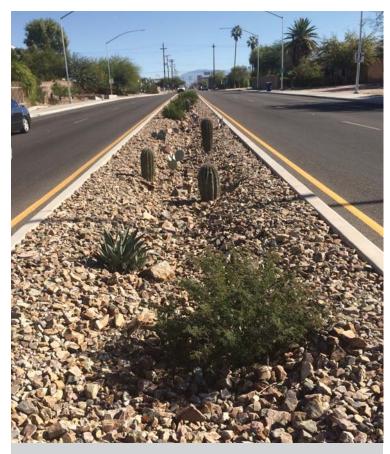
Sonoran native plants in median swale along St. Mary's Rd

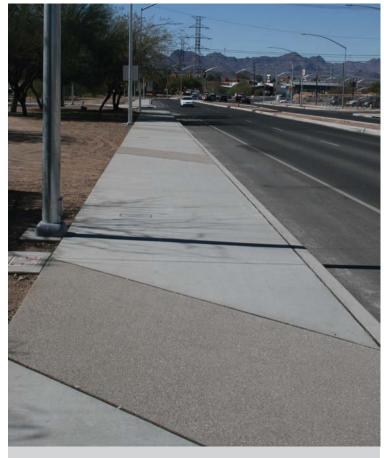
angled decorative sidewalk inlay along St. Mary's Rd
